# What Happened to Ballarat Tram No 30?

## **Reconstruction of Car 183**

By Richard Holmes

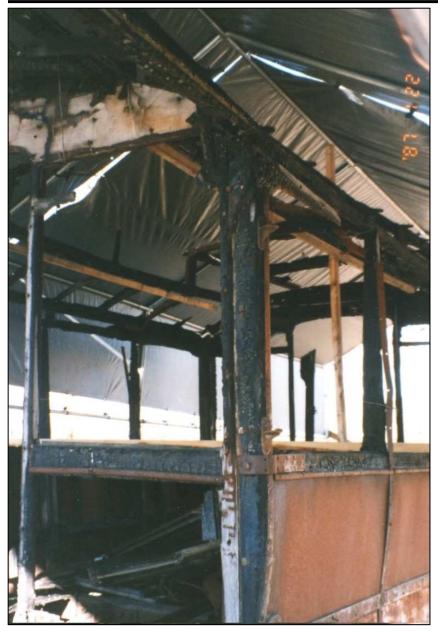
Before shipping to Oregon

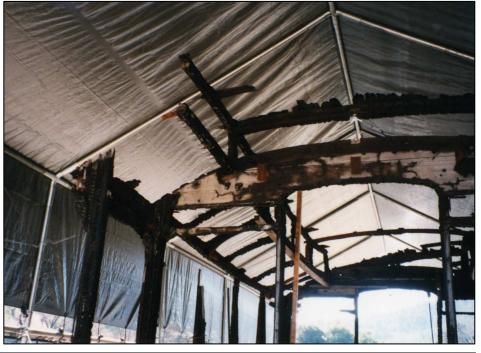
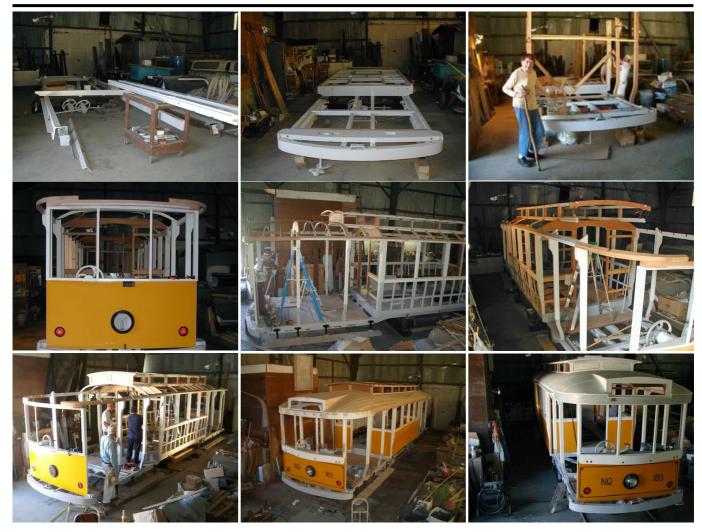
The car was shipped to Portland Oregon in 1980 where it caught fire. The fire destroyed most of the original wood structure.

**Above:** After the fire in Portland (As seen in 1987)

The extent of fire damage

The remains are protected by a tent.

Remaining from the original car was the steel frame and running gear and many burned timbers that were used as patterns to reconstruct the wood frame and body.

The entire body has been rebuilt as close to original design as possible using traditional mortise and tenon joinery from the frame up. Considerable emphasis was placed on maintaining the original structural design and construction techniques. The following sequence of photos shows the beginning of construction in 2005 to the point where the body is near complete, now work on the interior was started.

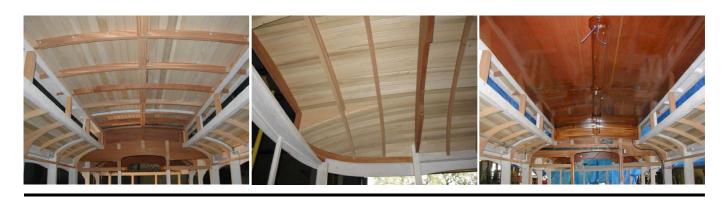
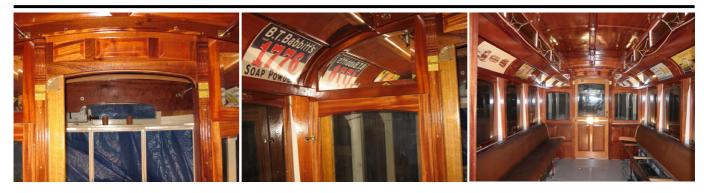
Above: The detailed pictures of the saloon finish

The interior of the car has been finished in African mahogany with some red oak shown in the sequence of pictures below. The interior was finished in a similar fashion to SEC Ballarat numbers 26 and 33 with mirrored sash at both end bulkheads. All finished brasses have been polished and recoated with lacquer before installation.

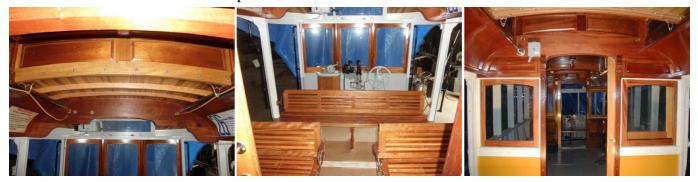
**Below:** The finish details of the open ends

The end benches are constructed of cherry and mahogany with tip-over backs that provide seating for approximately 10 at each end. The forward bulkhead behind the motorman was eliminated and the seating layout was changed in case it became necessary to allow for wheelchair access. All surfaces are finished with multiple coats of exterior varnish to provide for a lasting finish.. A sander is located under one of the seats at each end of the car operated by a foot button switch.

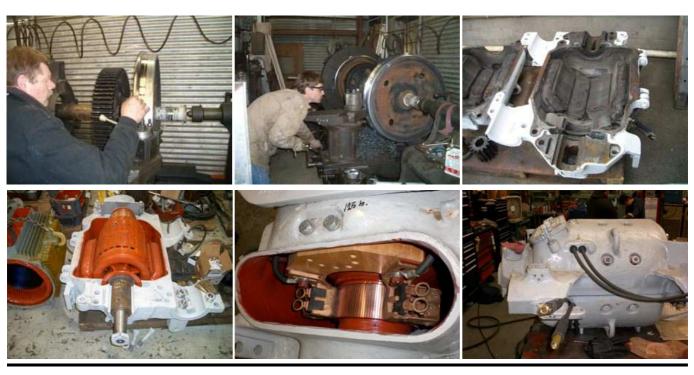
# **Below:** Rehabilitating the wheels and motors

The truck was completely dismantled and components repaired as needed. Frame holes which were found to be badly worn were welded and re-bored. All axel bearings were replaced with new babbitt and line bored. Springs were also replaced as required.

Both motors were completely disassembled and the commutators turned and slotted. The brush holders were replaced with new maple units with new brushes. The armatures and fields were re-insulated using a standard dip-and-bake process. All internal lead wiring were replaced and armature bearings were also replaced with new babbitt. Both motors underwent satisfactory bench testing before re-installation. All that remains now is to get the car back on railroad tracks for debugging and adjustment.
