# What Happened to Ballarat Tram No 30?

## **Reconstruction of Car 183**

By Richard Holmes

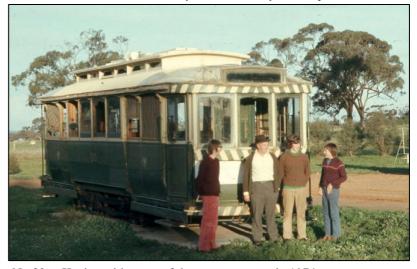
No 30 at Kaniva with some of the recovery team in 1974

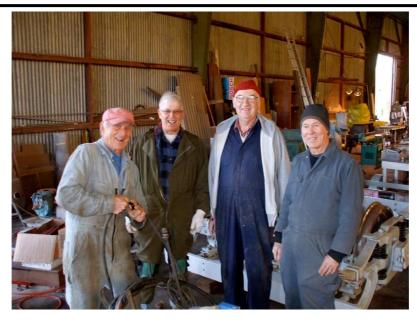
The group responsible for the reconstruction of this car, shown above, are Paul Class, Richard Holmes Jim Begear and Bud Stanton with funding from the Kairos Family Trust.
